The roof repairs to the church of All Saints Wytham.

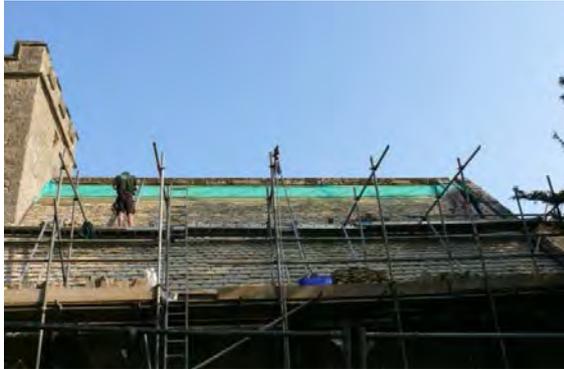
The south side of the nave roof under repair

During what were thought to be minor repairs to the nave roof in January 2011, it was found to be in danger of total collapse. It was therefore re-tiled in March/April that year. Unfortunately, the original tiles (Stonesfield Slate) were no longer available. Replacements were agreed with English Heritage. These look fine, but are much heavier than the originals, which set up an undesirable asymmetric loading on the nave roof. Because of this, and signs that other elements of the nave and chancel roofs were also deteriorating, the decision was taken to re-tile the remainder of the roof as soon as the money could be raised.

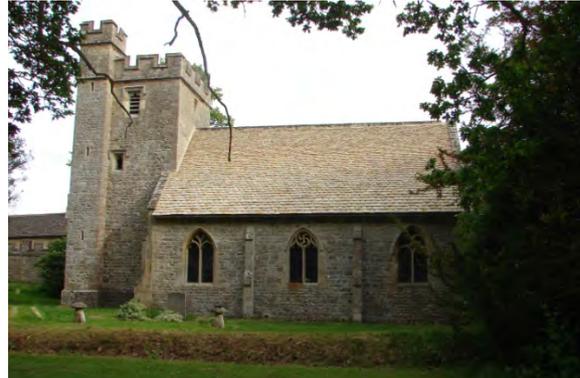
and completed.

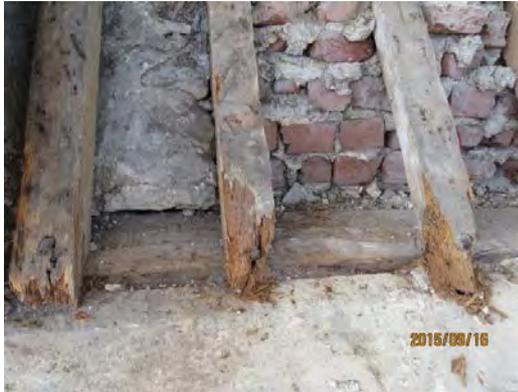
The roof beams on the north side of the chancel.

The south side of the chancel roof was in very poor condition. The battens to which the tiles were fixed were thin and of poor quality, and were rotten across almost the whole of the roof space - we were fortunate that a gale had not already removed the tiles. The north side was in better condition, the battens being of much higher quality. However, a coping stone on the eastern gable end of the chancel had split, and that next to it had been replaced at some time with an ordinary garden paving stone, which did not overlap its neighbour as designed. This had allowed water to run down the inside of the wall, rotting the feet of the first four rafters where they sat on the wall plate. This could have produced a partial collapse of the north east corner of the chancel roof at some time in the future, which would have produced a considerable leak. We were again fortunate to find this before such a collapse occurred.

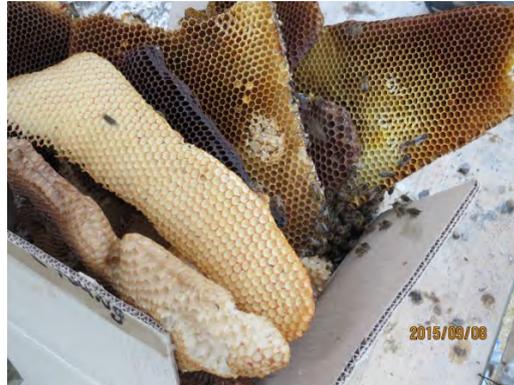
The bees nest being removed from the roof.

The cement flashing against the tower wall had perished. The ingress of water here seems to have been prevented only by a bee's nest under the tiles at the corner! Many of the tiles were in poor condition, with evidence of de-lamination. They were very roughly cut – probably the 1812 originals. They were purchased by the roofing company, but will need a lot of trimming before they can be reused.

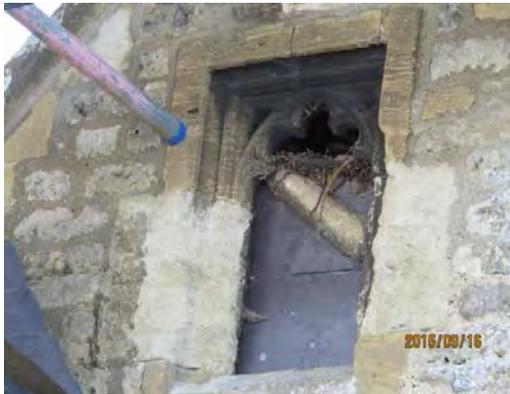
Chancel arch window, blocked by the heater flue

At the top of the chancel arch at the end of the nave, there was originally a window. This was covered with slate, presumably when the hot water heating system was installed in 1893, as the boiler flue would have

exited at this point. The slate had broken, and the window had become an access point for jackdaws. The window was blocked off with slate once more, and the frame restored. The chancel cross, which had disappeared at some point in the past, was also replaced.

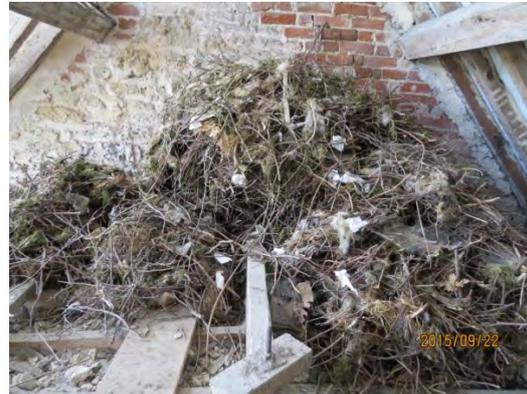
Jackdaws nest in the roof over the nave!

The roof was lined with sheep's wool insulation as work progressed, and a walkway laid along the length of the nave and chancel lofts. As the remaining ridge tiles were re-fixed, holes were left for the bats to go in and out of the roof space both in the nave and the chancel. The window in the chancel loft at the east end of the church has been covered on the inside with wire mesh to prevent the future ingress of birds, while allowing the bats continued access.
